**UNDERWATER FACILITIES
INSPECTION AND ASSESSMENT
AT**

**ARDM
NAVAL SUBMARINE BASE
KINGS BAY, GEORGIA**

FPO-1-85(19) JUNE, 1985

**COLLINS ENGINEERS, INC.
600 WEST JACKSON BOULEVARD
CHICAGO, ILLINOIS 60606**

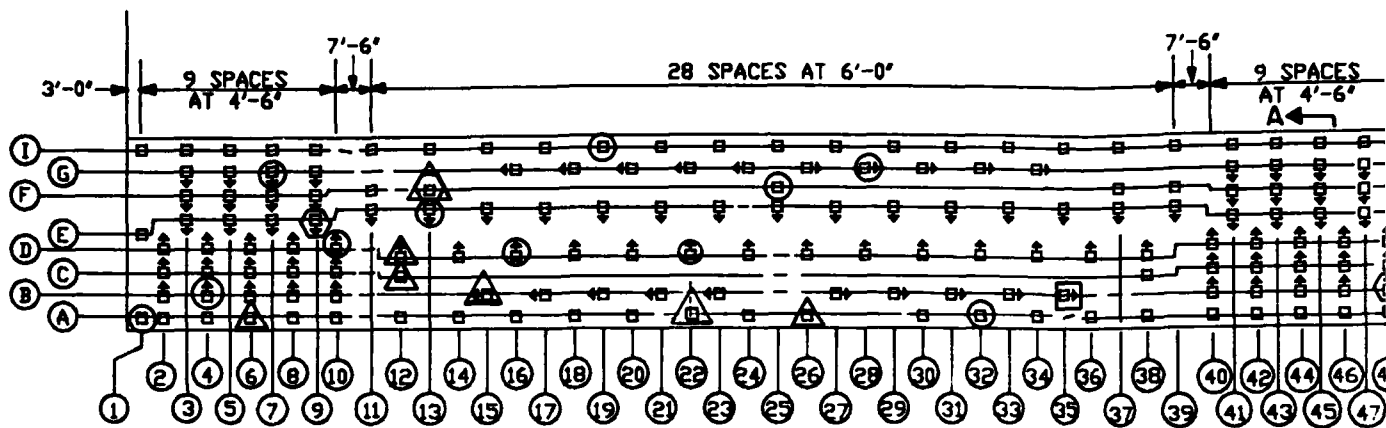
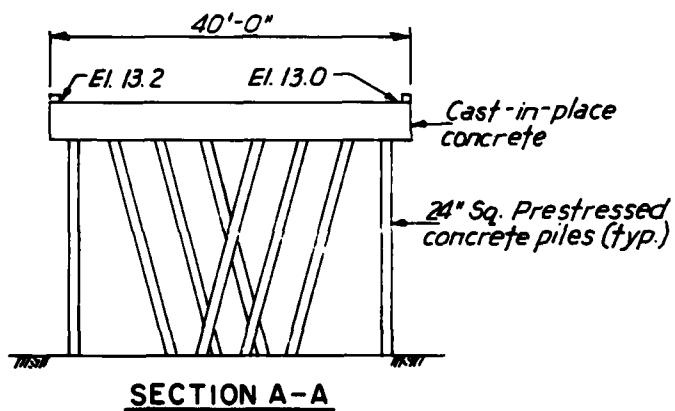
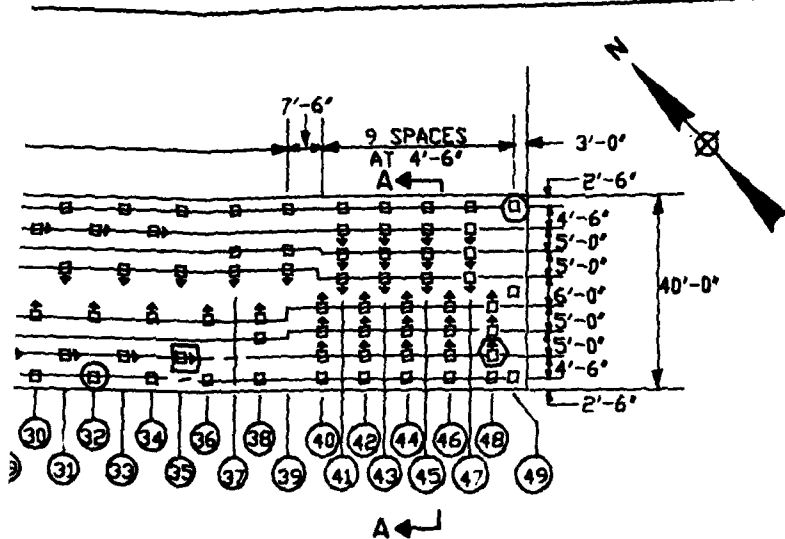
DEEDS ENGINEERING, INC. 800 N. JACKSON CHICAGO, ILLINOIS	CHESAPEAKE DIVISION NAVAL FACILITIES ENGINEERING COMMAND WASHINGTON, D.C.	
	NAVAL SUBMARINE BASE KINGS BAY, GEORGIA	FIG. NO.
	SPUD DOLPHIN CONTRACT NO. 602477-00-0-0004	4.2 -1

The prestressed concrete piles of the spud dolphin are in excellent condition underwater. No evidence of distress below water was found. During the inspection, wire rope lifting loops were found on three piles. These loops are corroding, and strands of some of the loops have broken due to corrosion. The location of the loops appears to be random, depending in part on the depth to which the piles were driven.

Above water, the piles were generally found to be in excellent condition. There were, however, a few minor areas of chipped corners and localized scaling. Eight piles, 6A, 12C, 12D, 13B, 15A, 22A, 26A, and 35B had minor, but measurable areas of chipped and scaled concrete. Refer to Page A-2 in the Appendix for a summary of the defects found during the inspection. Refer to Photographs 4.2-2 through 4.2-4 and 4.1-5 through 4.1-15 for underwater views of piles which are typical of conditions at the spud dolphin.

It is recommended that the areas of scaling and chipping on Piles 6A, 12C, 12D, 13B, 15A, 22A, 26A, and 35B be repaired by patching with surface applied epoxy mortar. Prior to applying the mortar, any loose concrete should be removed and any exposed reinforcing steel should be cleaned. The estimated cost of these repairs is approximately \$5,000. Refer to the Appendix (Page A-3) for a breakdown of the cost estimate.

It is also recommended that the corrosion of the submerged lifting loops be investigated further. NSB personnel indicated that some of the piles of the facility would be removed in the future as part of planned construction at the ARDM. NSB personnel suggested and it is recommended that these piles be examined to determine if the corrosion of the lifting loops is progressing into the pile, and to ascertain if the lifting loops were cast in contact with the mild steel reinforcement or the prestressing strands of the piles. After that inspection of the interior of the piles is completed, an evaluation can be made as to whether cleaning of the piles, removal of the lifting loops and patching of the piles is required. It is recommended that, in the future, lifting loops be removed and the surface of the pile be patched during the construction period.
